Lake Washington
Improvement Association
of Meeker County

2023 Dam Inspection Report

Lake Washington Dam - NID MN 01186 - Meeker County

Dana Dostert PE, PG - February 7, 2024

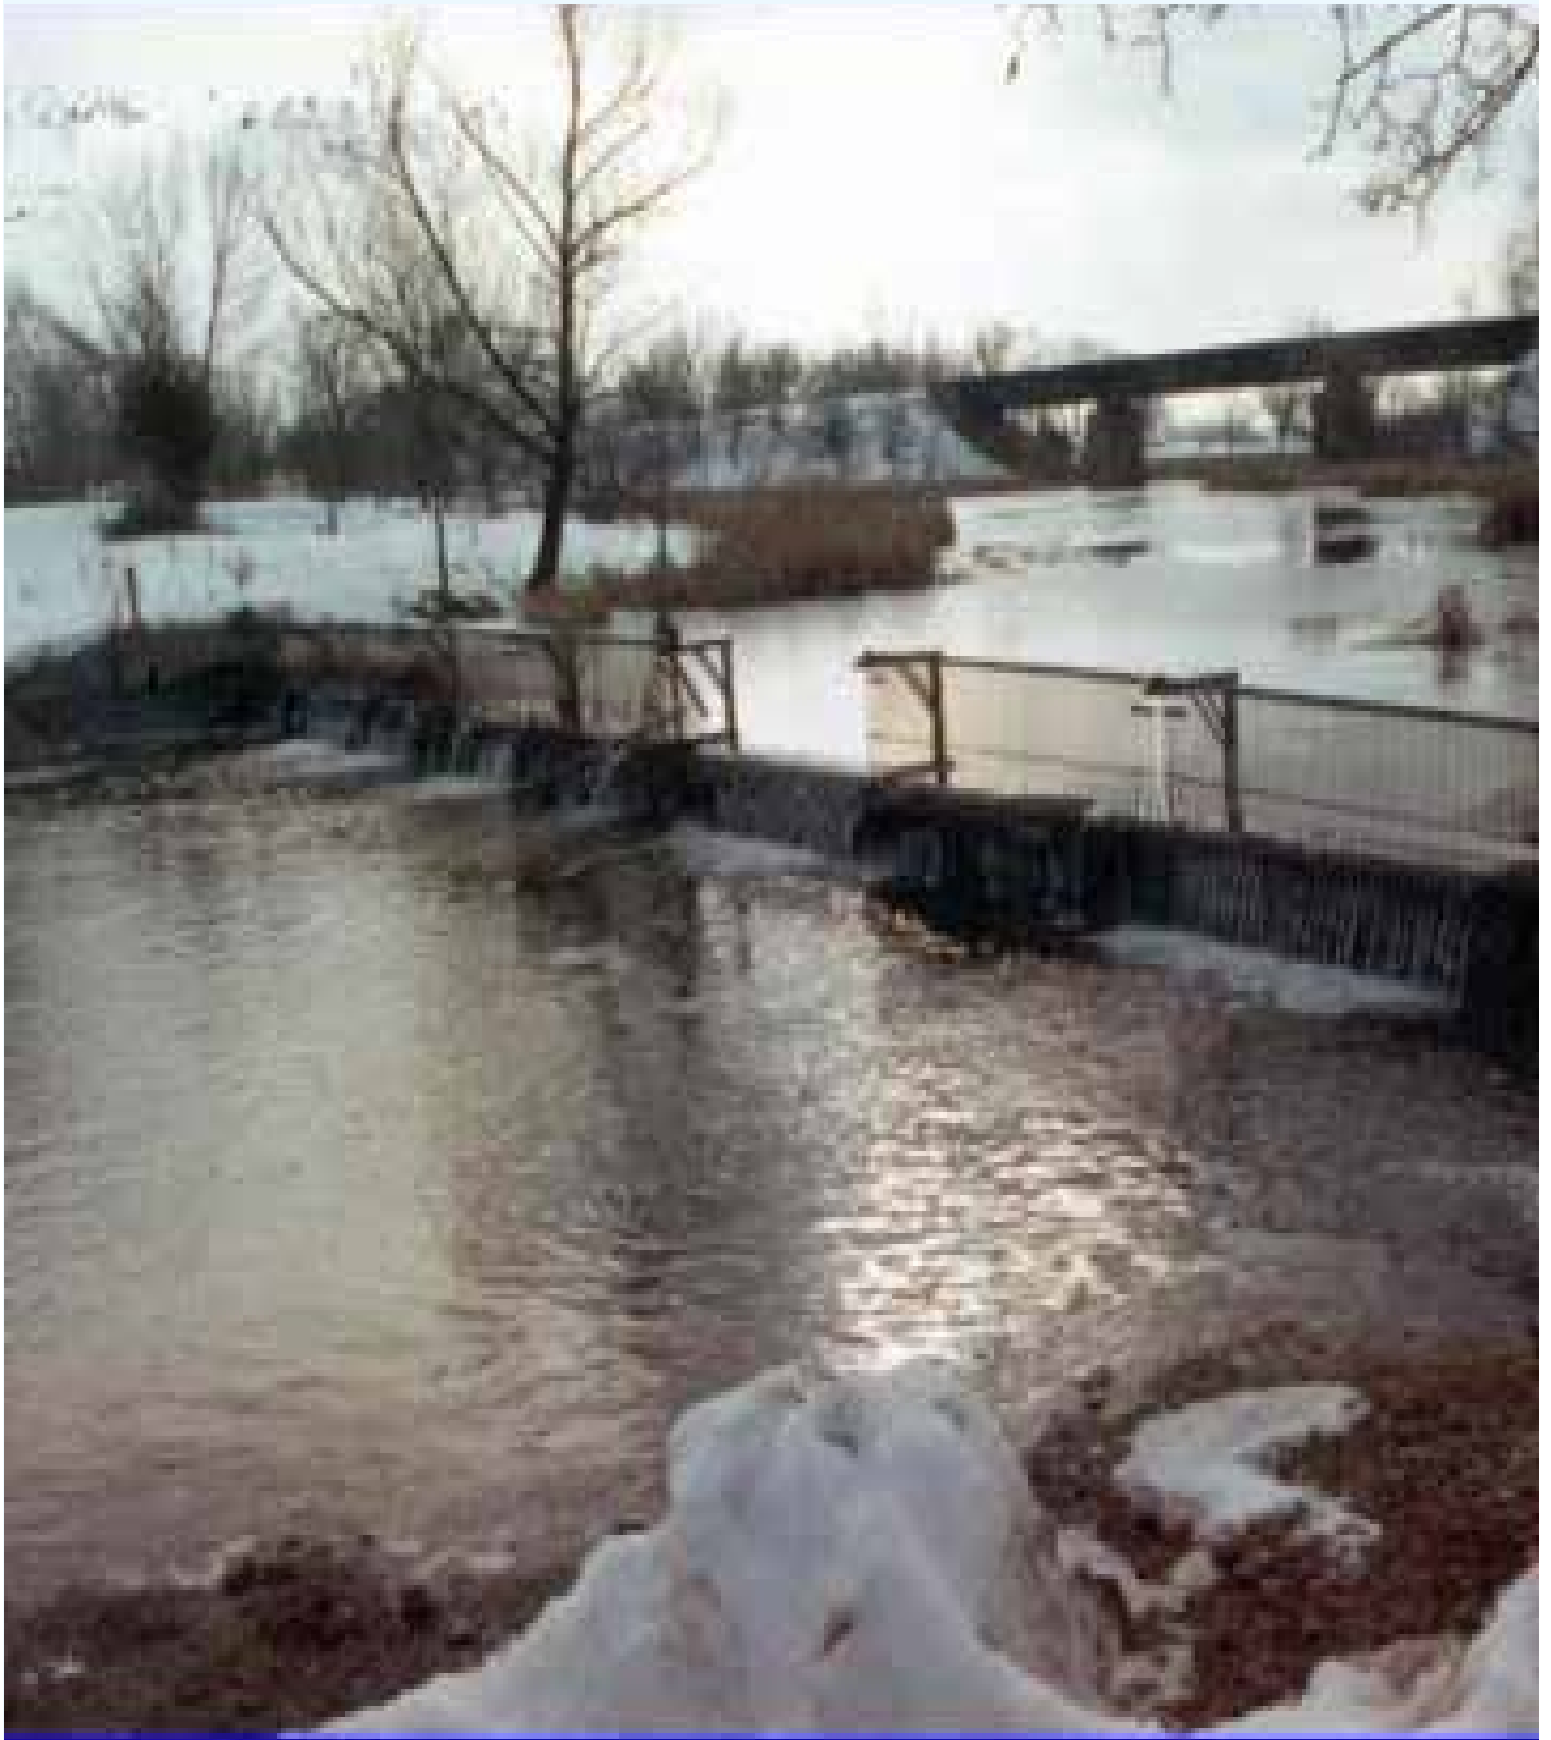
Lake Washington Dam in 1992. Note carp barriers.

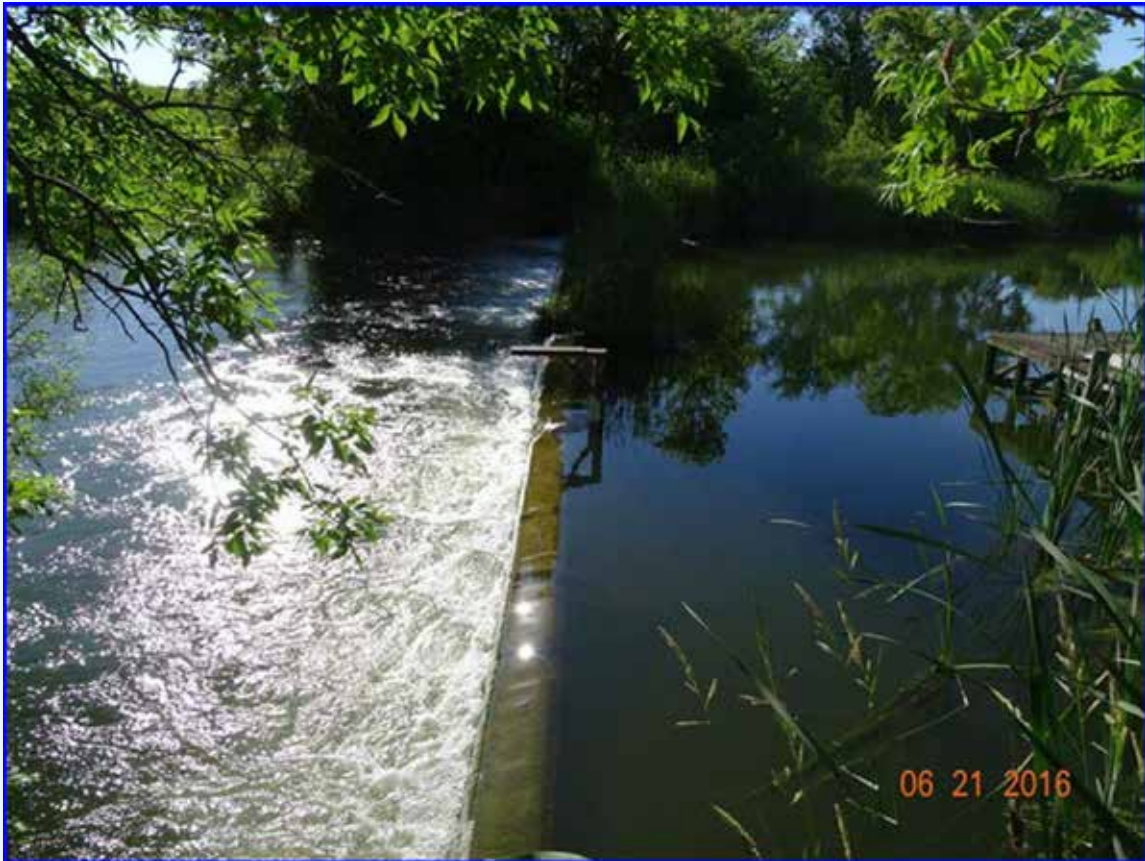
In the original dam, steel posts were attached to the dam to support a carp barrier. The last remaining post is located at this scour site. In our 2016 inspection, this post was used to support a stream gage. In our 2023 inspection, we noted that the post has been knocked over and is laying across the scoured weir. It is our belief that as water was deflected around this post, and increased in velocity, it accelerated the scouring of the concrete weir. This was not noted in our 2016 inspection when the post was still in the upright position, but a review of the 2016 photos indicates that the scour process had already begun. ***While this scour area does not significantly impact water levels on Lake Washington, the scour should be repaired before it becomes larger.***

Lake Washington dam in 2016. Note the Carp barrier post and the deflected flow pattern at the post.

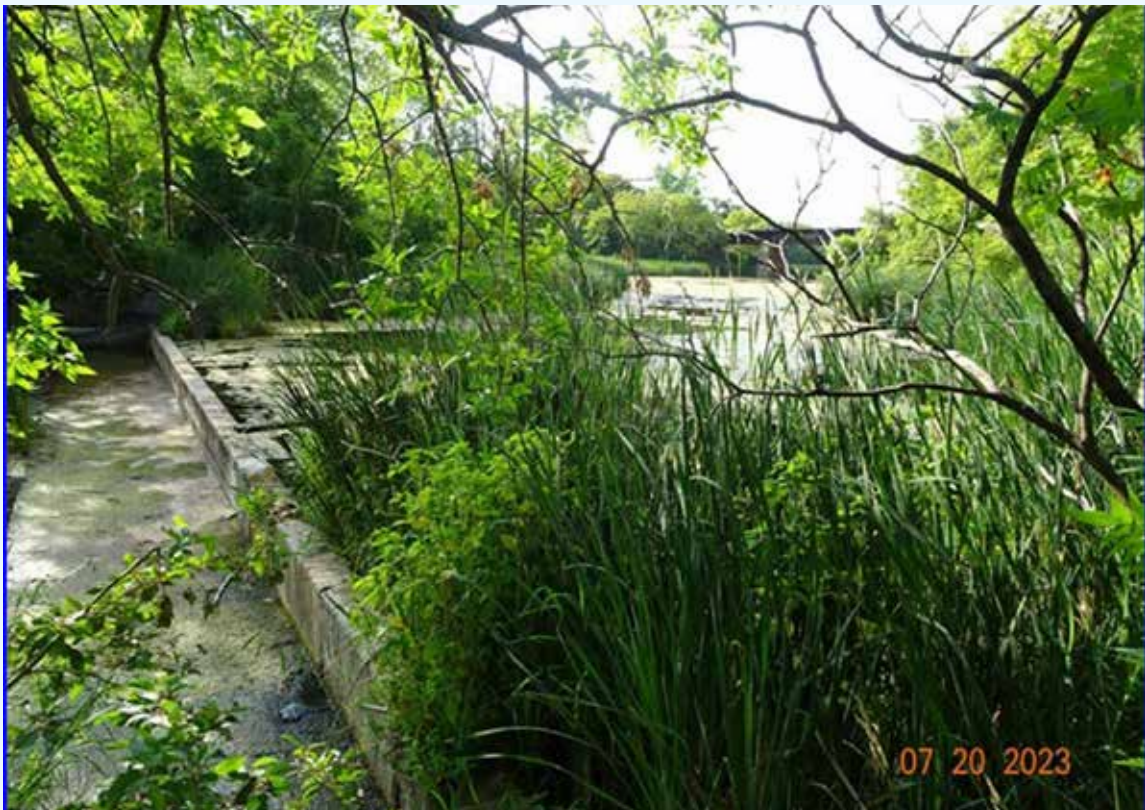
Dam Safety also noted that the channel upstream of the dam appears to be slowly filling with sediments and aquatic vegetation. Cattail bogs caught on the weir were noted impeding flows near both the left and right abutments.

Downstream face of the Lake Washington Dam. Note the floating cattail bogs at both the right and left abutments.

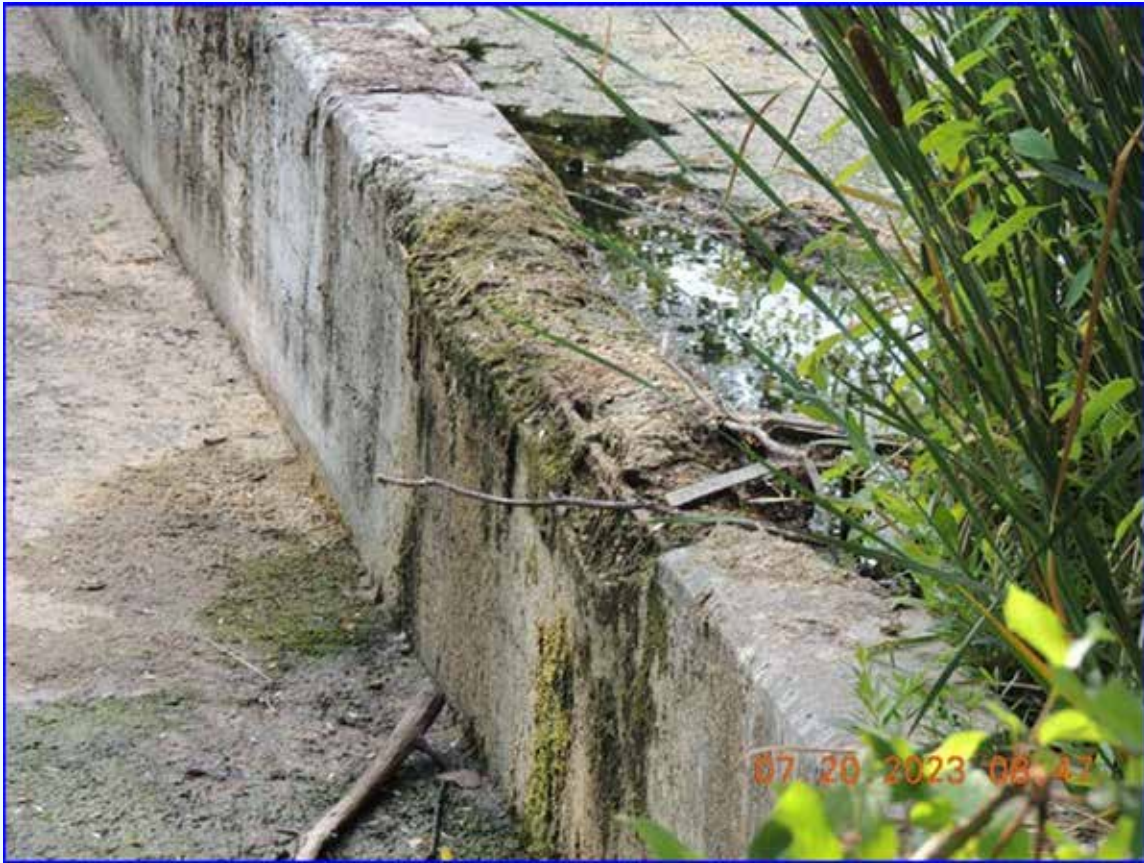
Approximately fifteen feet east of the left abutment is an area of significant erosion and deterioration of the concrete weir. The length of this erosion is estimated to be in the range of five to six feet. The center of the weir has eroded down approximately three to four inches but the concrete erosion on the upstream and downstream faces at this location is approximately one-foot. A significant length of rebar is exposed in this area.

Concrete scour near the left abutment. Note the exposed rebar. Remnants of the steel carp barrier post can be seen on the lower right of the scour.

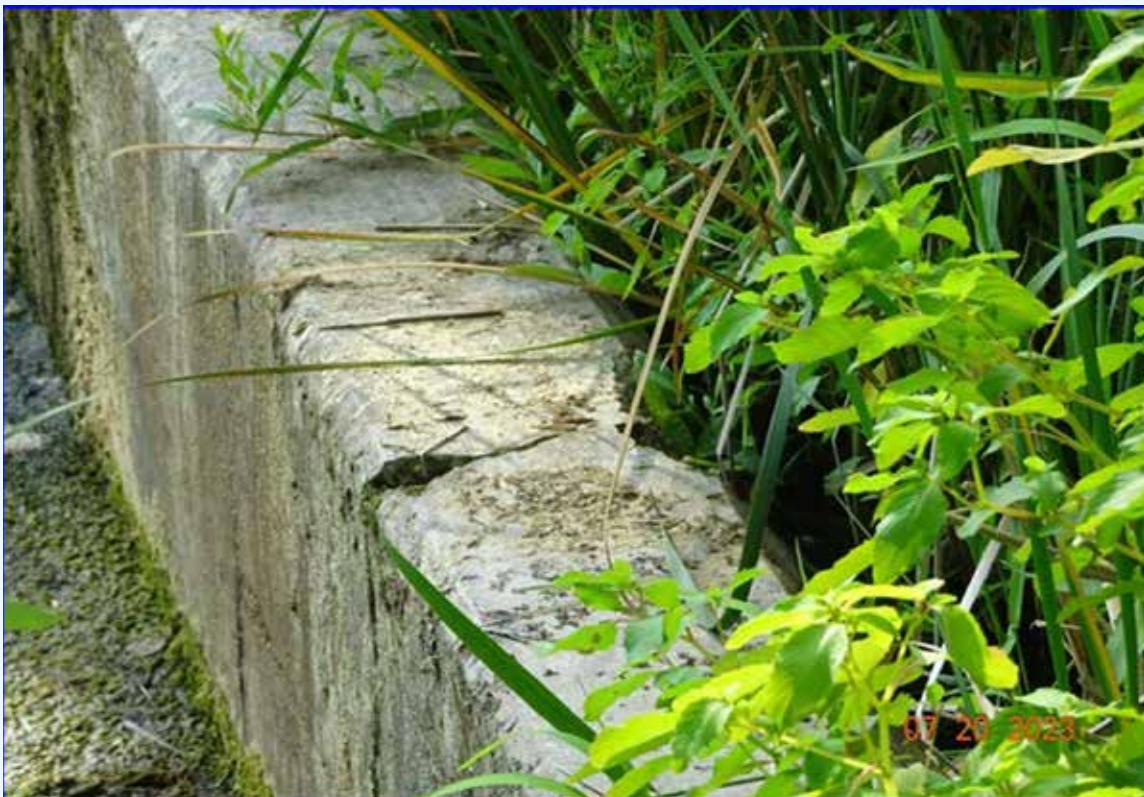
A small crack along a concrete seam was also noted. This crack is several feet to the east of the left abutment and between the abutment and the larger scour site. ***This is a minor crack at this time but we expect it to grow larger over the coming years.***

Crack in the concrete approximately five feet from the left abutment. Note the scour and vegetation on the upstream side of the weir.

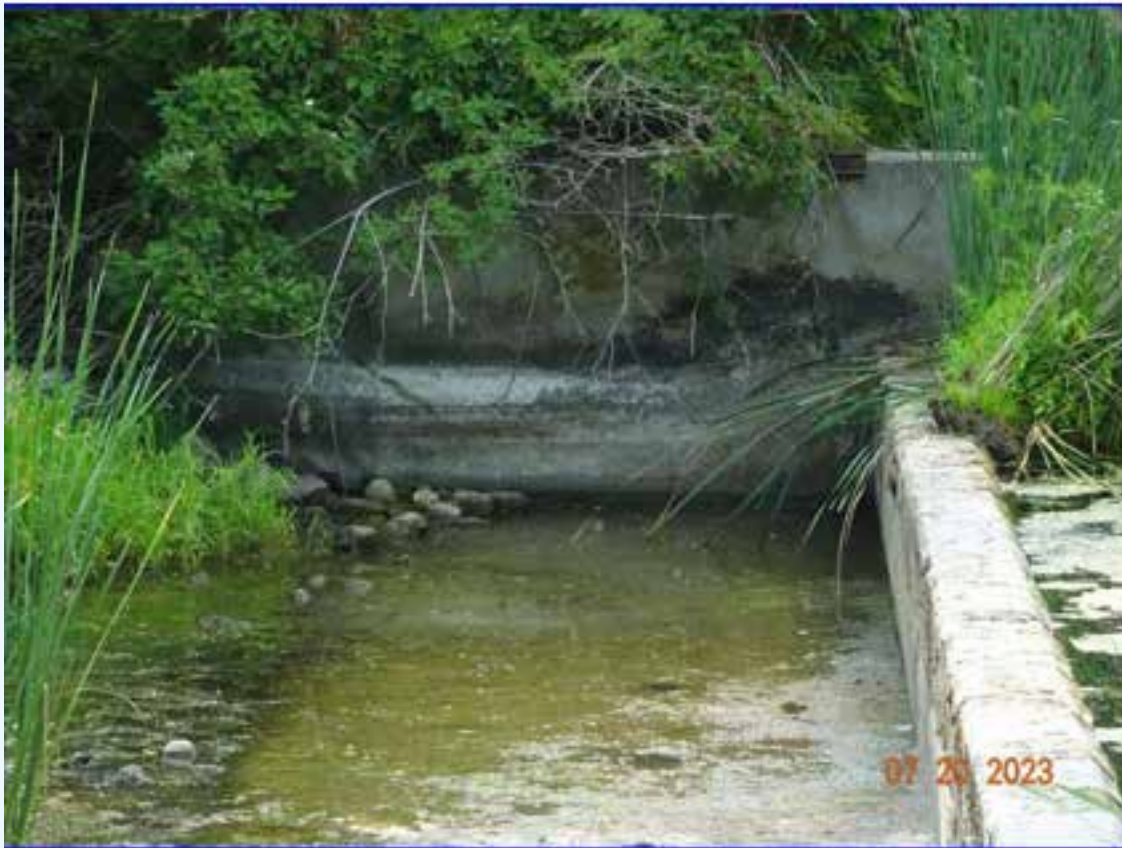
Dam Safety found the Lake Washington Dam to be in fair condition. The sill of the dam below the concrete weir, and the left (west) abutment are in good condition. The right (east) abutment is choked with trees and woody vegetation and is difficult to access. ***This vegetation should be removed as tree roots can disturb and displace concrete components of dams.***

Photograph of the right abutment. Vegetation should be removed from the abutment and the area immediately around it. Note the floating bog on the weir. The left abutment (not pictured) is in good condition.

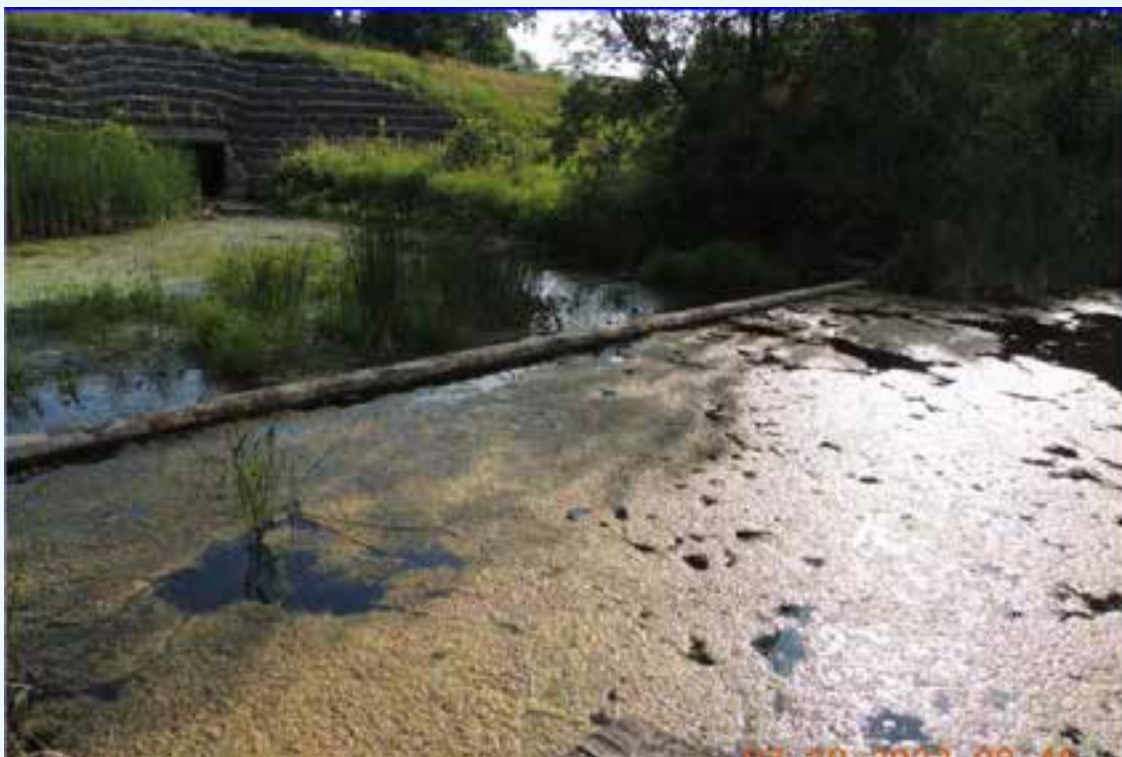
Upstream face of the weir. Note the emergent vegetation. The channel between the old dam and especially the railroad crossing and the new dam appears to be filling with sediment.
